***Characterization and Evaluation of Tire-Roadway  
Interface Stresses***

***Report GCT-03-03***

***Ministère des Transports du Québec***

***February 2003***

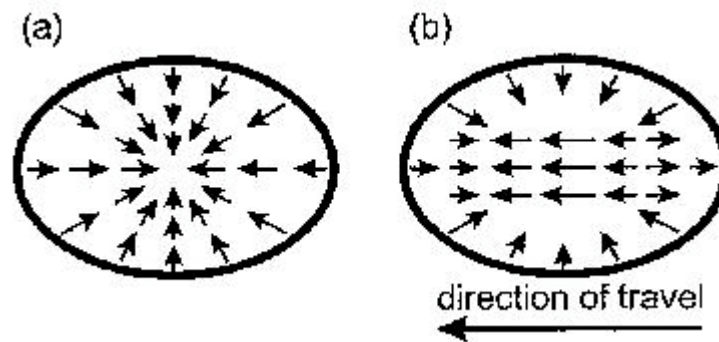
- Vertical contact stresses under a tire are not uniform. The distribution of these stresses depends on a tire's design;
- Vehicle speed does not affect vertical stresses but does affect longitudinal stresses;
- When a tire is static, the friction between the tire tread and the road surface develops tangential forces directed inward toward the centre of the tire-roadway contact area;
- When a tire is moving, longitudinal shear develops at the centre of the contact surface (Figure 1).

**Figure 1 - Contact stresses on the roadway surface around the edge of a tire footprint for (a) a static tire and (b) a free wheel (Tielking and Roberts, 1987)**

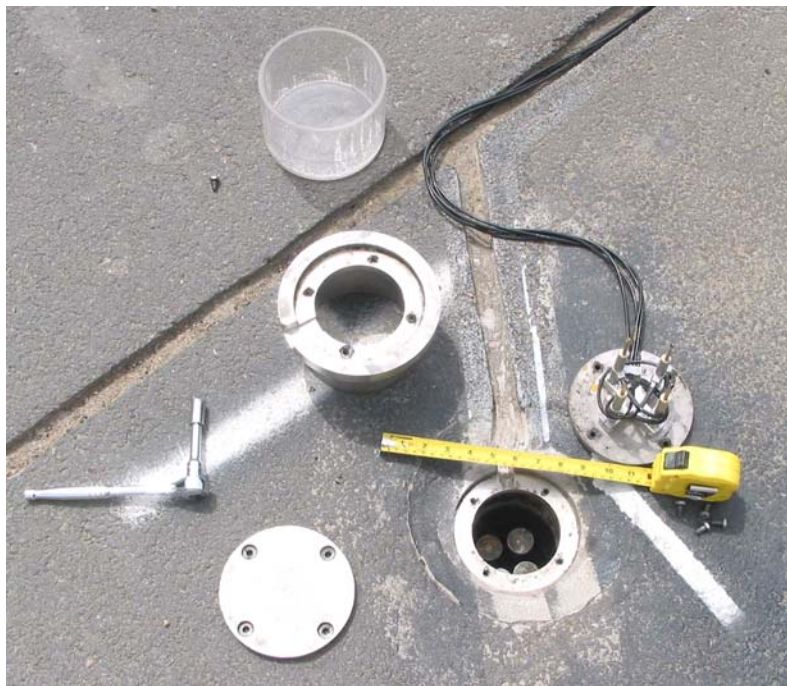
Figure 12 - Multilevel deflectometer read head disassembled

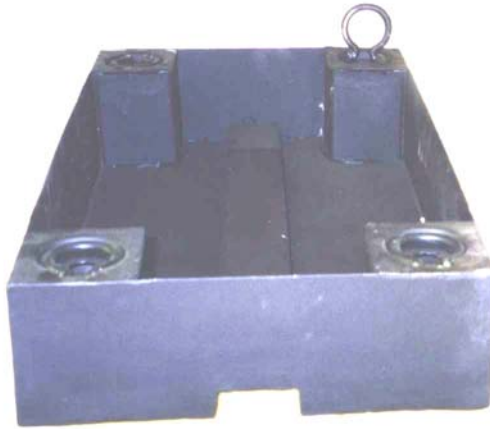
After constructing an initial slab, the next step in the preparations for the summer trials was to design a mold for producing the slab and to design the components needed to install it on the SERUL site. A steel mold (Figure 14) was designed to contain the epoxy/aggregate mix. The mold-mix combination made up the final trial slab. Its dimensions were 2' long (609 mm), 1' wide (304.8 mm), and 4" deep (101.6 mm).

**Figure 14 – Mold for the instrumented slab**

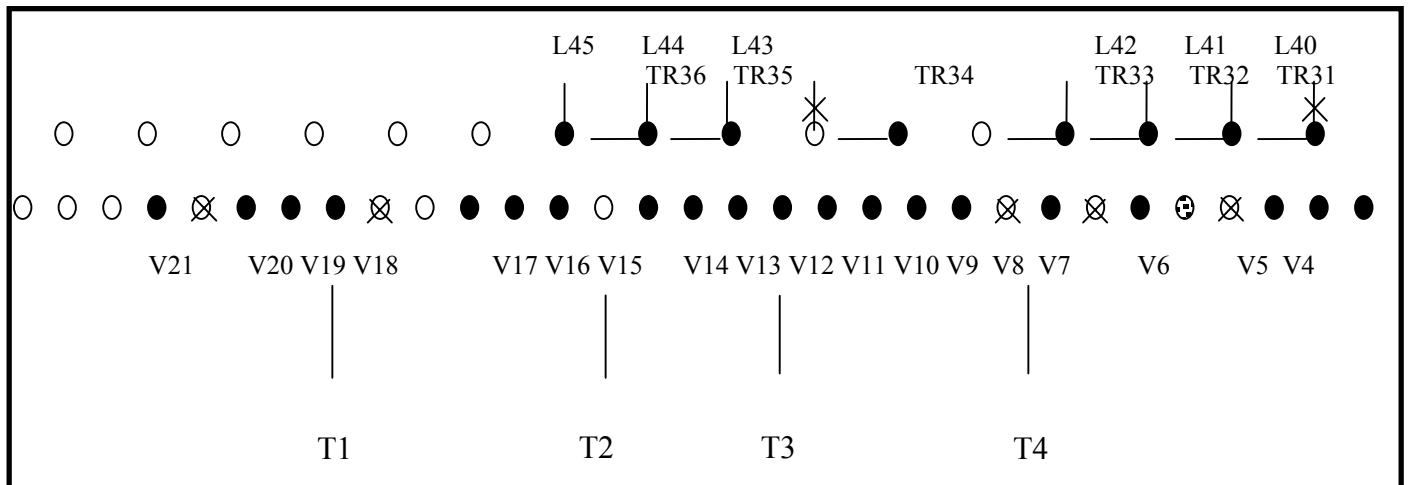
Figure 16 - Final placement of the gauges in the slab (V: vertical gauges, TR: transversal gauges, and L: longitudinal gauges)

The final device used to collect data during the summer trials is shown in Figure 16. The operational gauges are shown in black and the defective ones in white.

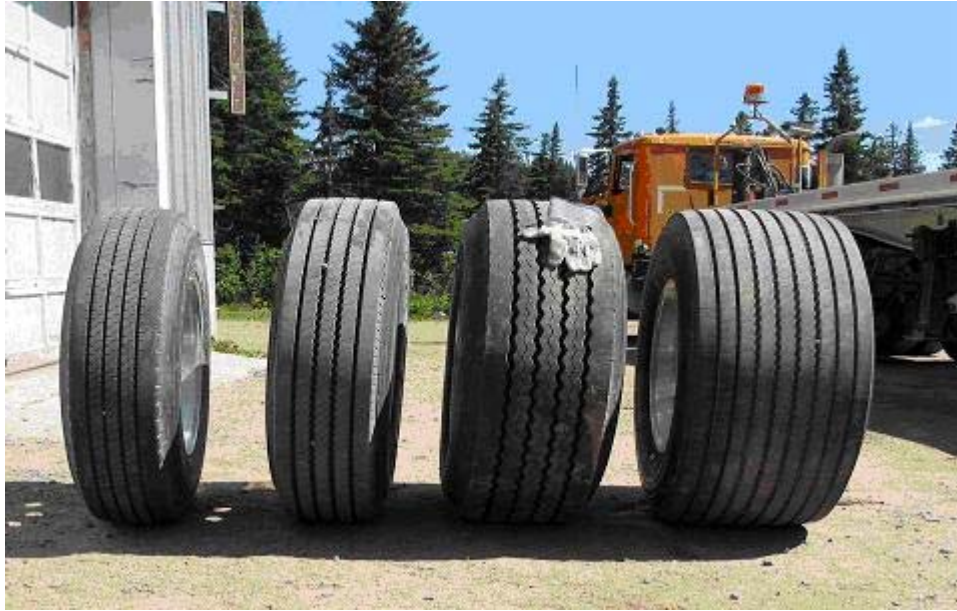
- Four tire types (Figure 19) were tested: dual tires 11R22.5 (Bridgestone) and 12R22.5 (Michelin), and single tires 385/65R22.5 (Michelin wide) and 455/55R22.5 (Michelin extra-wide).
- Five loads: 3,000, 4,000, 5,000, 6,000, and 7,000 kg / half axle (two dual tires equivalent to a single tire). These loads were obtained by installing 2,200 kg concrete blocks before the trials.
- Three inflation pressures: 560, 730, and 900 kPa. These inflation pressures were chosen to cover the range of commonly used pressures.

**Figure 19 - The four tire types tested (from left to right):  
11R225, 12R22.5, 385/65R22.5 and 455/55R22.5**

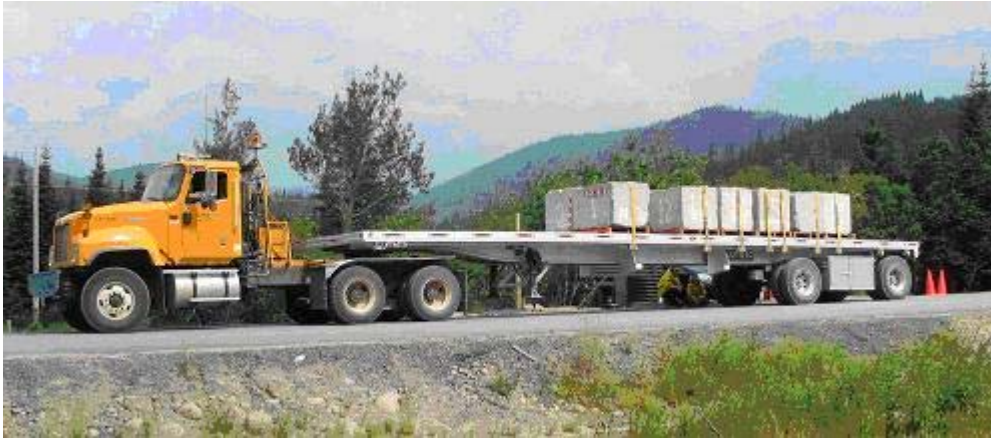
- Concrete blocks were placed on the truck trailer (Figure 20) as indicated in Appendix 4;
- Tire loads were checked by placing portable scales under each tire on the trailer's two back axles (Figure 21). These readings were taken near the instrumented area to reproduce load conditions for each tire identical to those occurring as the vehicle moved over the sensors;

**Figure 20 – Truck used for the trials**

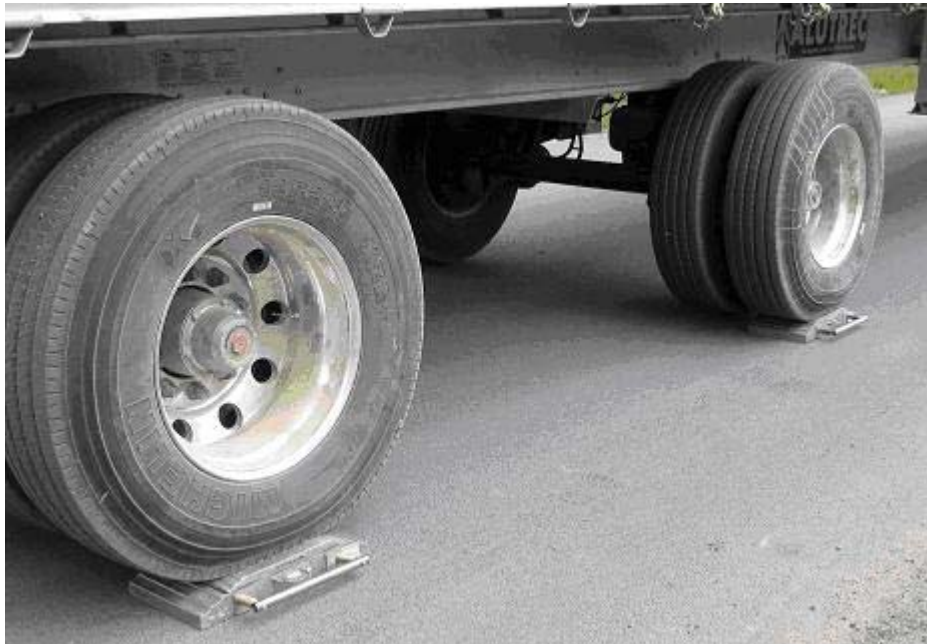
**Figure 21 – Portable scales placed under the truck's wheels to measure the load**

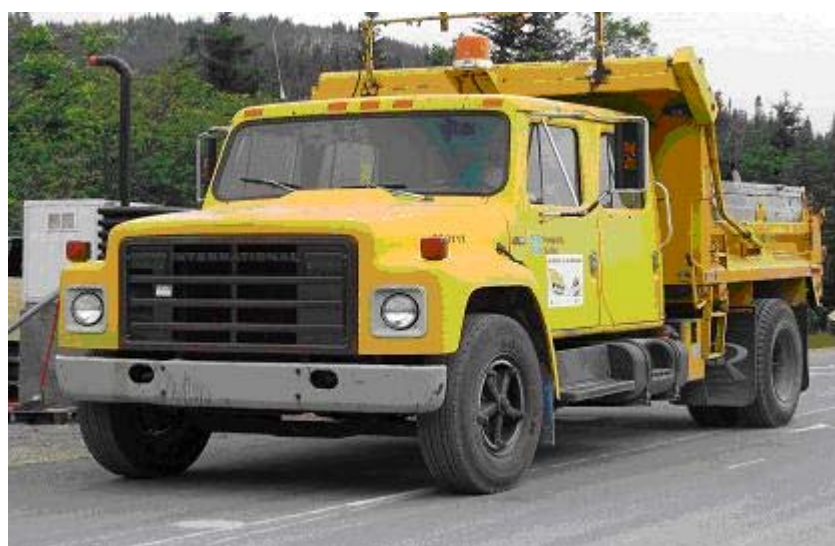
The distortions and deflections caused by the Benkelman vehicle (Figure 23) were measured every sixth pass of the truck, to serve as a control. Here are the Benkelman vehicle's specifications:

- Type of axle: single with dual tires;
- Axle load: 8,165 kg;
- tire type: radials with a 203 mm tread (11R22.5)
- tire pressure: 550 kPa

**Figure 23 - Benkelman vehicle**

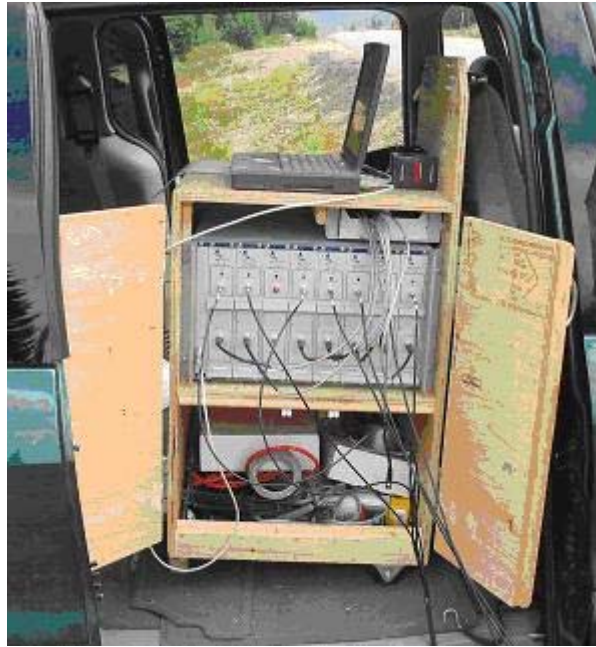
The signals from the multilevel deflectometer movement sensors and the distortion gauges at the pavement base were transmitted over fibre-optic cables (Doré and Duplain, 2002). A specific data collection system was therefore required. This system consisted of a device for sending and receiving light signals (BUS device) and a laptop computer for recording the readings using data collection software (Figure 24). The data were collected at a frequency of 500 Hz.

**Figure 24 - Distortion gauge and multilevel deflectometer data collection system**

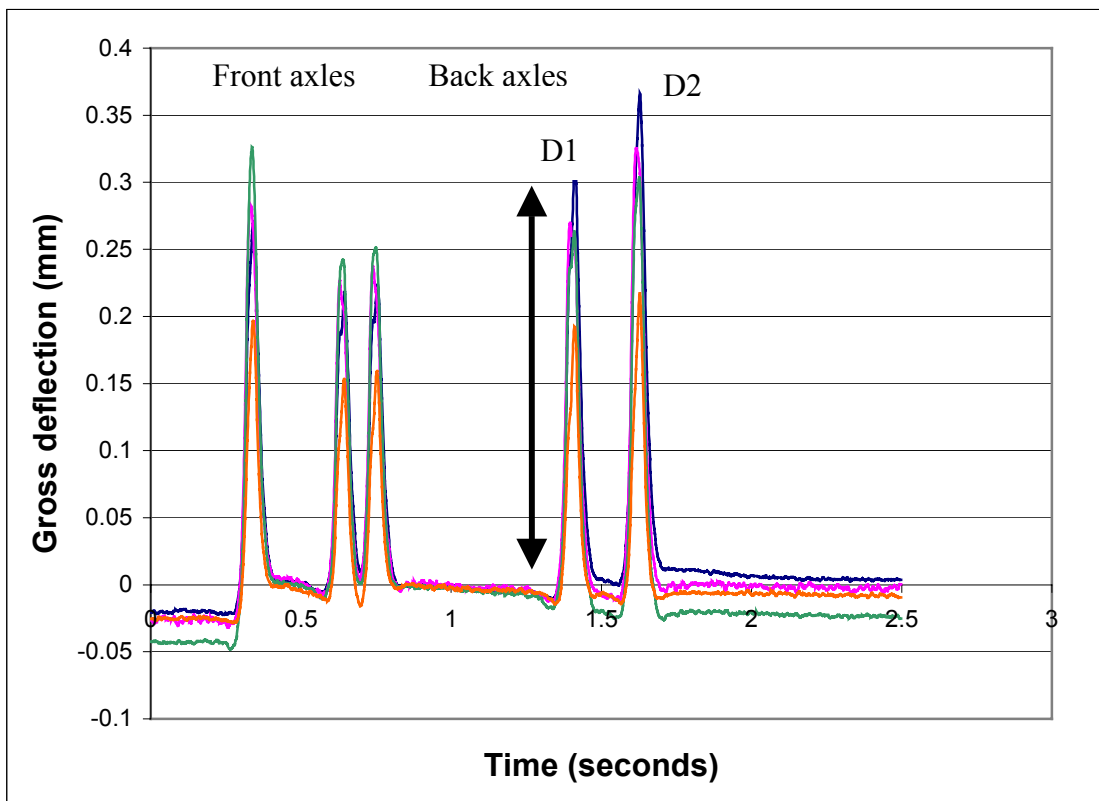
The computer recorded the deflectometer data as files containing deflection readings correlated to time. Typical signals captured by the multilevel deflectometer are presented in Figure 25. The first three peak readings correlate to the tractor's single and double axles; the next two correlate to the trailer's two back axles. Each curve reflects the readings taken by one of the four deflectometer plates.

**Figure 25 - Typical signal obtained from the multilevel deflectometer**

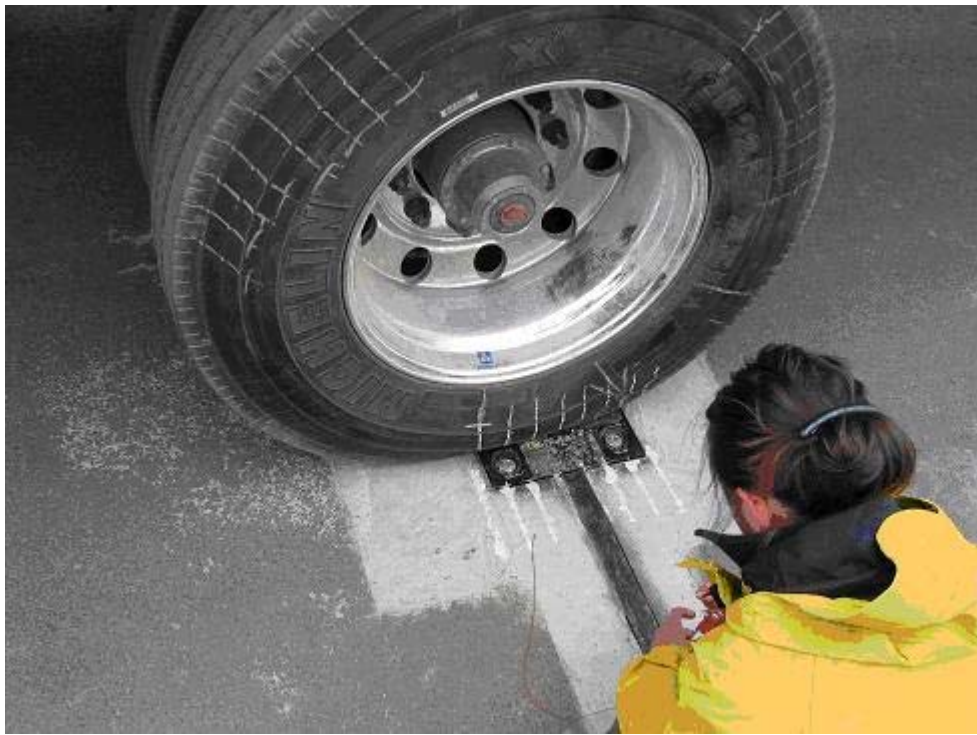
**Figure 28 – Tire advancement control procedure**

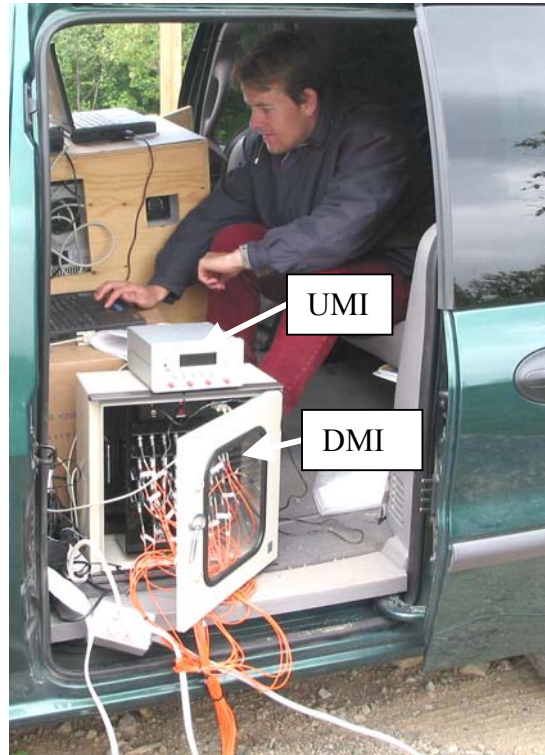
**Figure 29 – Fibre-optic slab gauge data collection system**

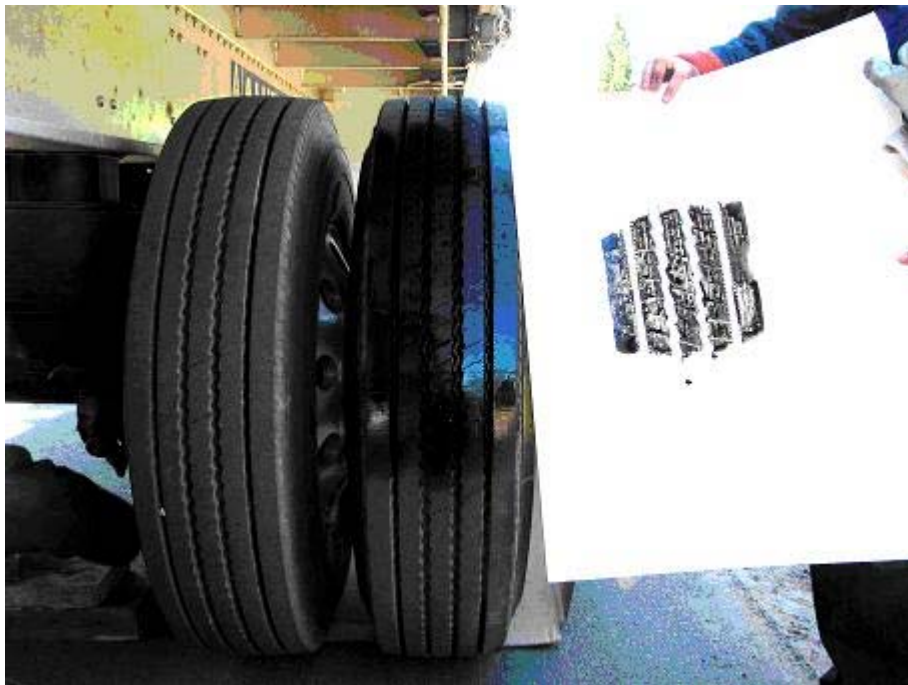
To obtain prints, tires were covered with paint and then pressed onto a piece of paper (Figure 31). Tire prints were taken for each configuration during the spring trials but only once per tire (at 1,500 kg/tire and 900 kPa) during the summer trials for control purposes. The tire contact area on the roadway was measured using the tire prints. Samples of each tire type are shown in Appendix 13. The surface areas of the tire prints are given in Appendix 13. The gross area correlates to the tire print on the roadway, including the spaces between the ribs, while the net area may be associated with that of a smooth tire, without treads. It is clear that greater loads increase the tire-pavement contact area. This observation applies irrespective of inflation pressure.

**Figure 31 - Taking a tire print**

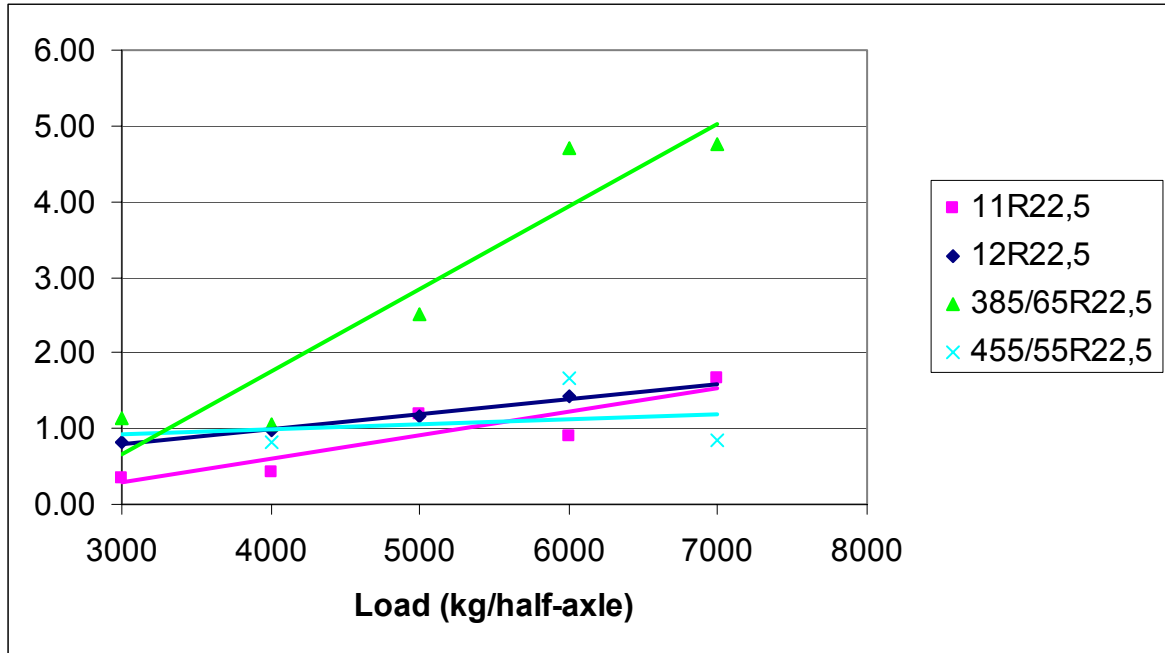
To analyse the findings more easily, the values for pavement base distortions, various tire types, and various loads were only presented graphically (figures 33 and 34) for the 730 kPa inflation pressure, the one most commonly used by carriers. Furthermore, the linear trend curves were drawn and the distortion values calculated (tables 4 and 5), based on the equations found, for the allowable loads, i.e. 15,500 kg or 3,875 kg/half-axle in the spring and 18,000 kg or 4,500 kg/half-axle in the summer.

**Figure 34 -  $N_{Benkelman}/N_{trial}$  ratio corresponding to the distortions at the pavement base in relation to load per half-axle at a pressure of 730 kPa (summer trials)**

Comparing spring and summer distortion gauge data, i.e. figures 33 and 34, yields road-friendliness observations with respect to fatigue cracks and different tire types in relation to load.

From the point of view of fatigue cracks, the dual tires are less damaging to the roadway than the wide tires in the spring, although the 455/55R22.5 extra-wide tire is less damaging than the 385/65R22.5 wide tires. However, in the summer, the dual tires and the extra-wide tire are equally road-friendly and the wide tire remains very damaging to the roadway.

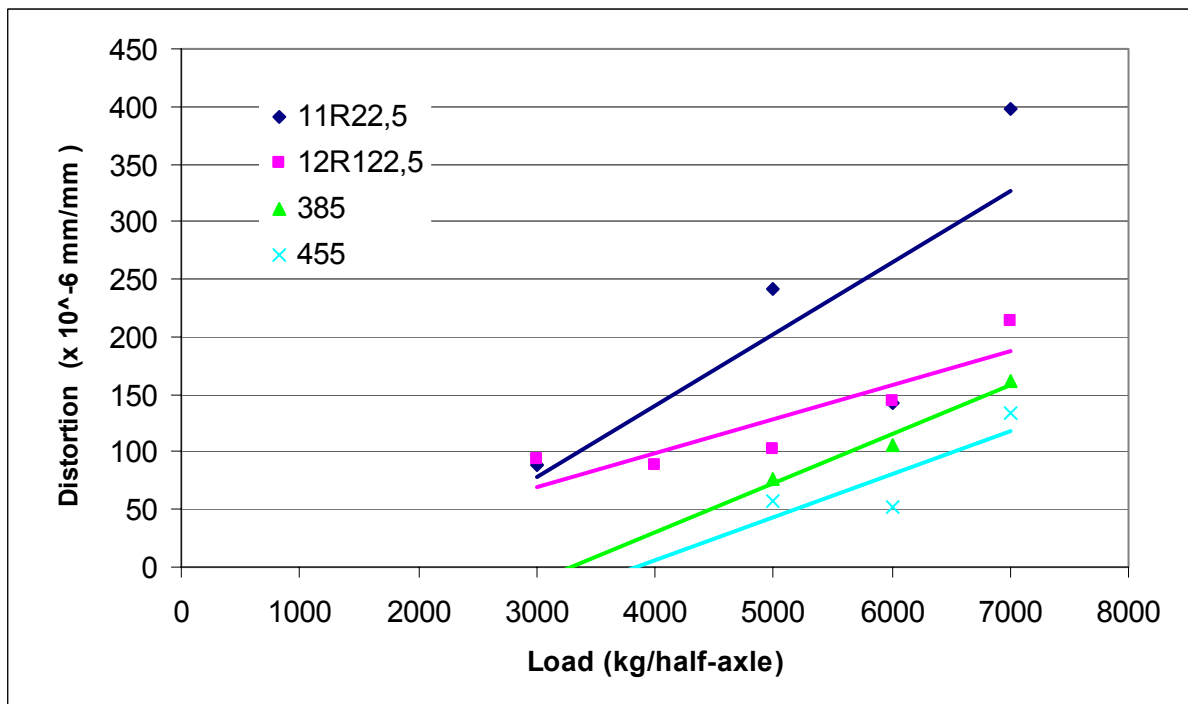
Based on the readings obtained from the distortion gauges, the average of the three maximum vertical distortion values was compiled for each configuration (Appendix 17), which made it possible to draw other graphs comparing the slab's response to the stress exerted by the various tires tested. Figures 35 to 37 present the maximum distortions detected in the slab for the different tire types in relation to load and the three inflation pressures. The figures show that distortions increase as loads increase, irrespective of the inflation pressure in question. As well, for both the lower pressures (560 and 730 kPa), the trend curves for the various tire types are fairly similar and all maximum distortion values are under  $200 \times 10^{-6}$  mm/mm. For the highest pressure, i.e. 900 kPa, both the 385 and 455 wide tires have the lowest distortion values and the 11R22.5 dual tire imposes the highest distortion values.

Figure 37 – Maximum distortions in relation to load at 900 kPa pressure
