AUSTROADS TECHNICAL REPORT

Safety Benefits of Improving Interaction between Heavy Vehicles and the Road System

Austroads Project No. ST1143

Austroads Publication No. AP-T119/08

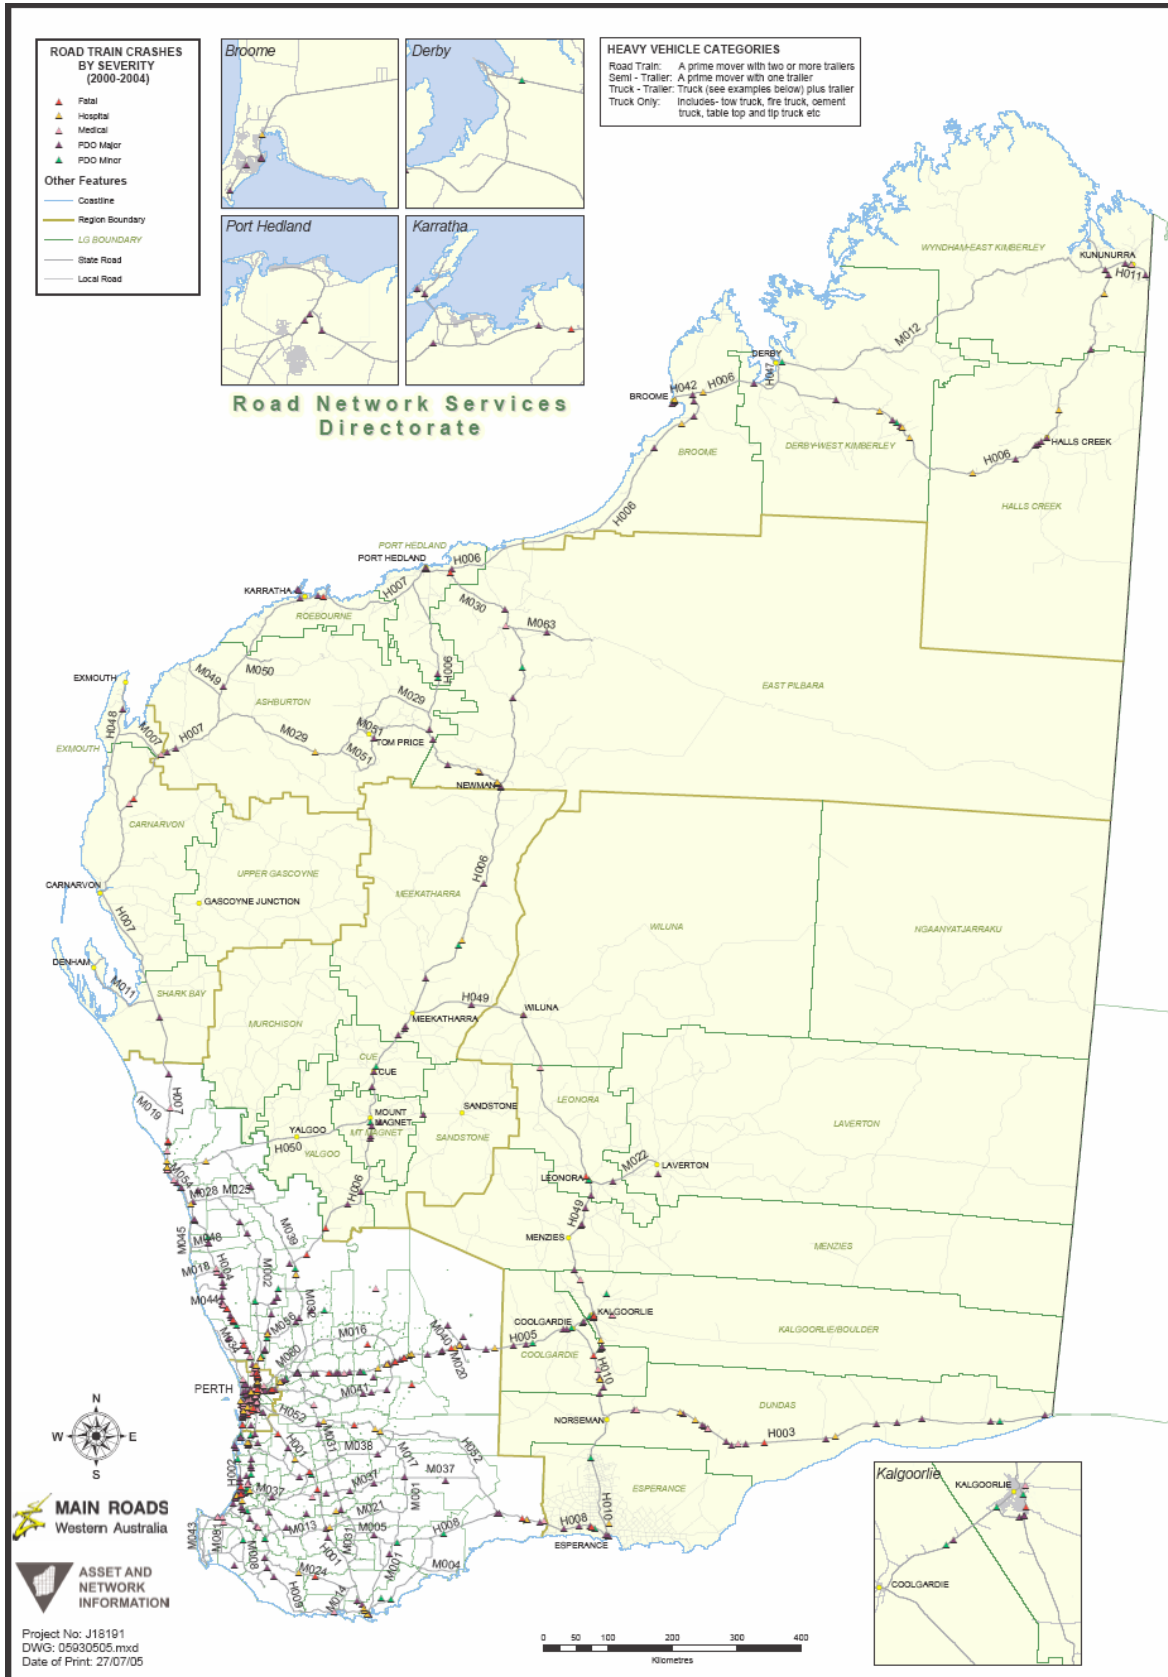
Figure 3.1: Map used by Main Roads WA to identify heavy vehicle crash blackspots

Consultations with state road authority representatives and a representative of the NZ Ministry of Transport revealed that some work has been conducted on a local basis by most jurisdictions. For example, Figure 3.1 depicts a plot of truck crash locations produced by Main Roads WA to help identify heavy vehicle crash black spots. However, such projects tend to be small in size and not typically focussed upon the factors of the roadway that may influence heavy vehicle crashes.

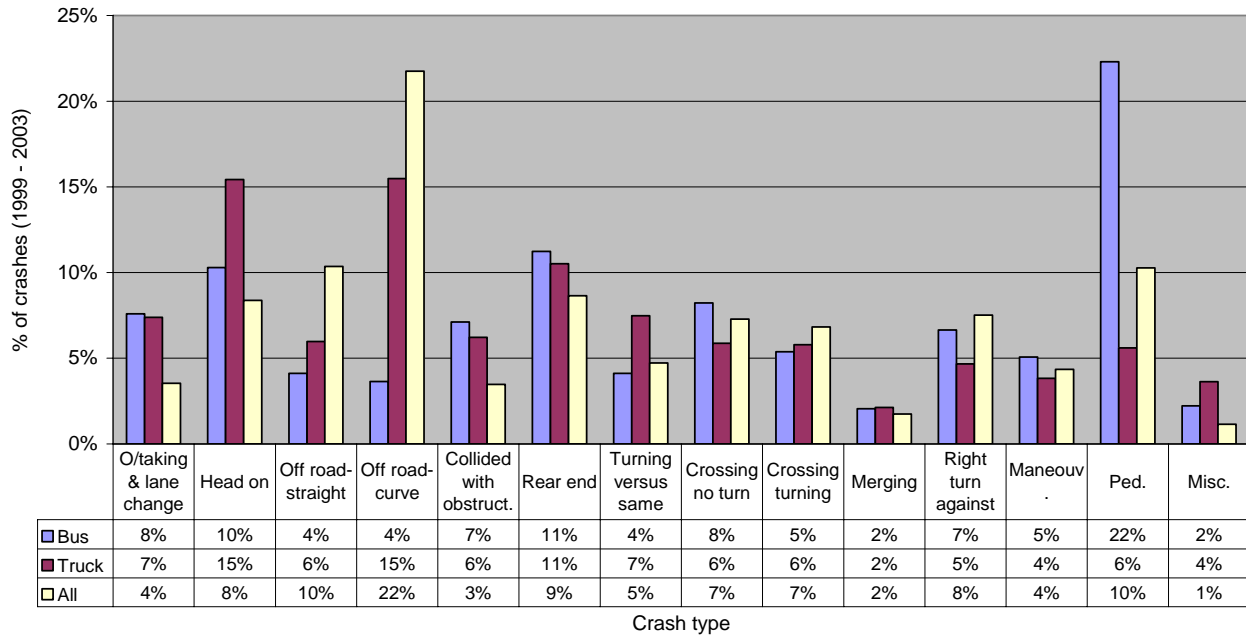
Figure 4.3: Crashes by crash type - for comparisons between vehicle types (New Zealand)

For New Zealand (Figure 4.3) trucks were involved in comparatively few run-off road crashes.

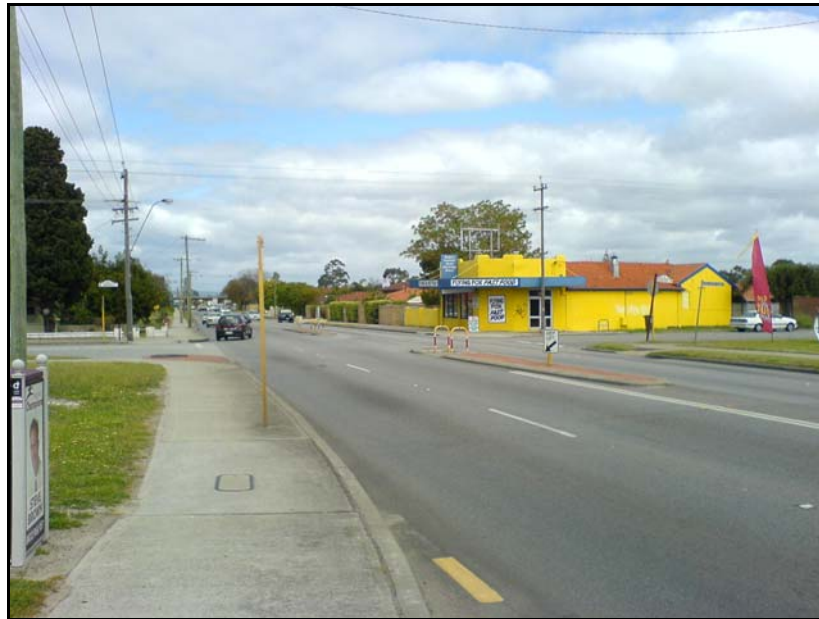
Figure 6.1: Site 1

One of the major road engineering issues at this site, as indicated by the crash pattern described above and the site inspection, may be lane width. Wider lanes would decrease the probability of sideswipes by affording greater turning space for heavy vehicles turning left off the major arterial. Alternatively, it may be beneficial to consider restricting truck access to the intersecting road if an alternative truck route is practical.

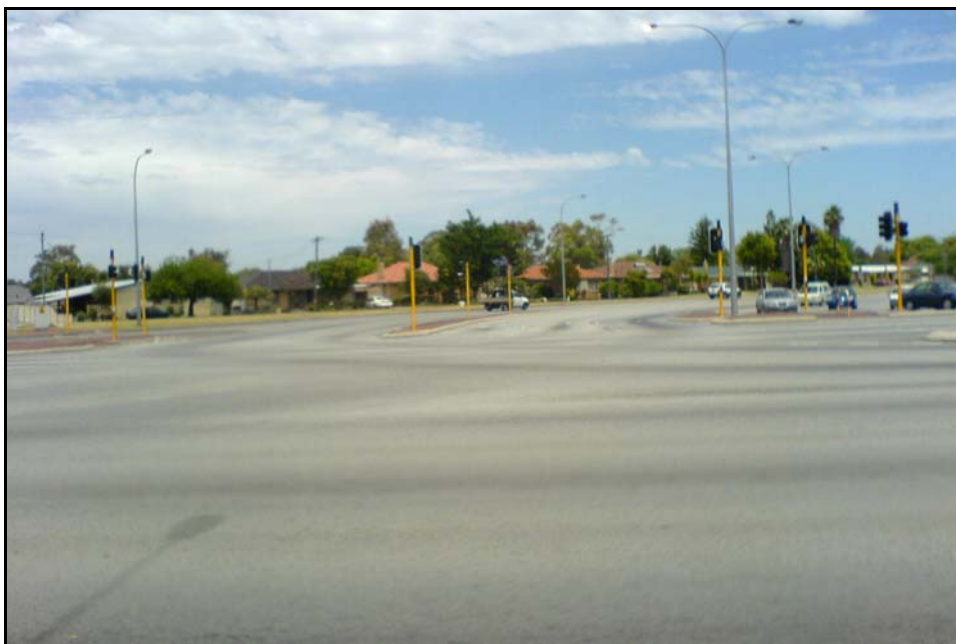
Figure 6.2: Site 2

Sixteen of the 21 heavy vehicle crashes at this urban intersection were rear-end crashes, typically the heavy vehicle was the colliding vehicle. All of these crashes occurred on a straight and level section of road in fine weather on a dry road and during daylight hours. The posted speed limit at the site is 60 km/h. Site inspections revealed a lack of delineation through the intersection (Figure 6.2). Conceivably this could result in drivers braking suddenly when they become uncertain of an appropriate path through the intersection, and being struck by a following vehicle. Trucks may be over-represented among colliding vehicles in rear-end crashes at this site due to their poorer braking performance.

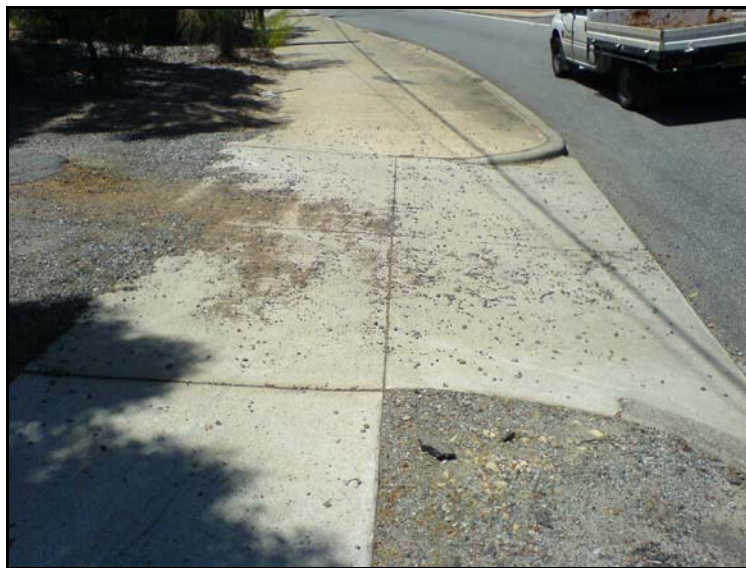
Figure 6.3: Site 3

This site is an urban mid-block section with ten of the 20 crashes recorded as occurring at a driveway or median opening. In nearly all crashes, the heavy vehicle was the colliding vehicle. The majority of crashes were either same direction sideswipes or rear-end. All of the crashes occurred on a straight section of road in daylight and under fine weather conditions on a dry road. The posted speed limit is 60 km/h.

Half the crashes occurred near driveways or median openings, which suggests that there may have been issues related to uncontrolled entry and crossing along this busy stretch of road. The site inspections confirmed this, revealing many private access points which must be negotiated at very slow speeds for both access to and egress from the main road. The poorer braking of heavy vehicles in particular may have been exacerbated by the fact that this road segment is on a slope. In addition, the incidence of sideswipes might suggest inadequate lane width for heavy vehicles, site inspections confirmed that lane width was approximately three metres on some parts of the segment.

There is also loose material present on the driveway depicted in Figure 6.3. This has the potential to reduce the acceleration capabilities of a stopped vehicle and, if it is tracked onto the through carriageway, it poses a skid resistance risk for heavy vehicles.

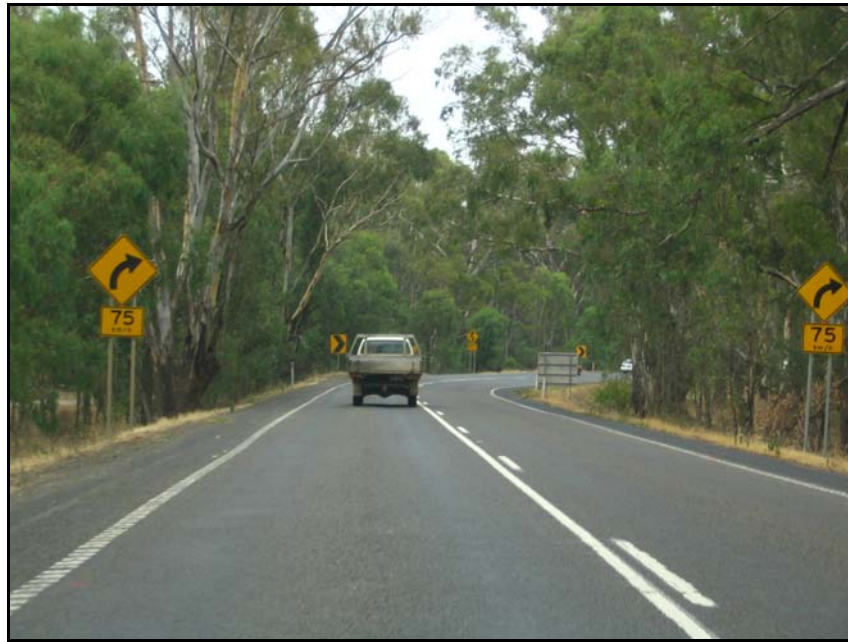
Figure 6.4: Site 4

There four run-off road crashes at this rural midblock. All crashes involved an articulated truck and all occurred on a bend in dry conditions. Three of these crashes occurred in either darkness or at dusk. Site inspections revealed good curve delineation and the presence of audio tactile edge lining (although the value of this for heavy vehicles is unclear). Signage located at the site indicated that it has been identified as a high risk zone for heavy vehicles which were advised to adhere to advisory speed limits on curves, but some large trees were present within the clear zone at some of the bends (Figure 6.4). Although clear zone hazards do not cause crashes, they can result in more severe run-off road crashes, and for this site the presence of trees within the clearzone were considered to be a potential crash severity factor.

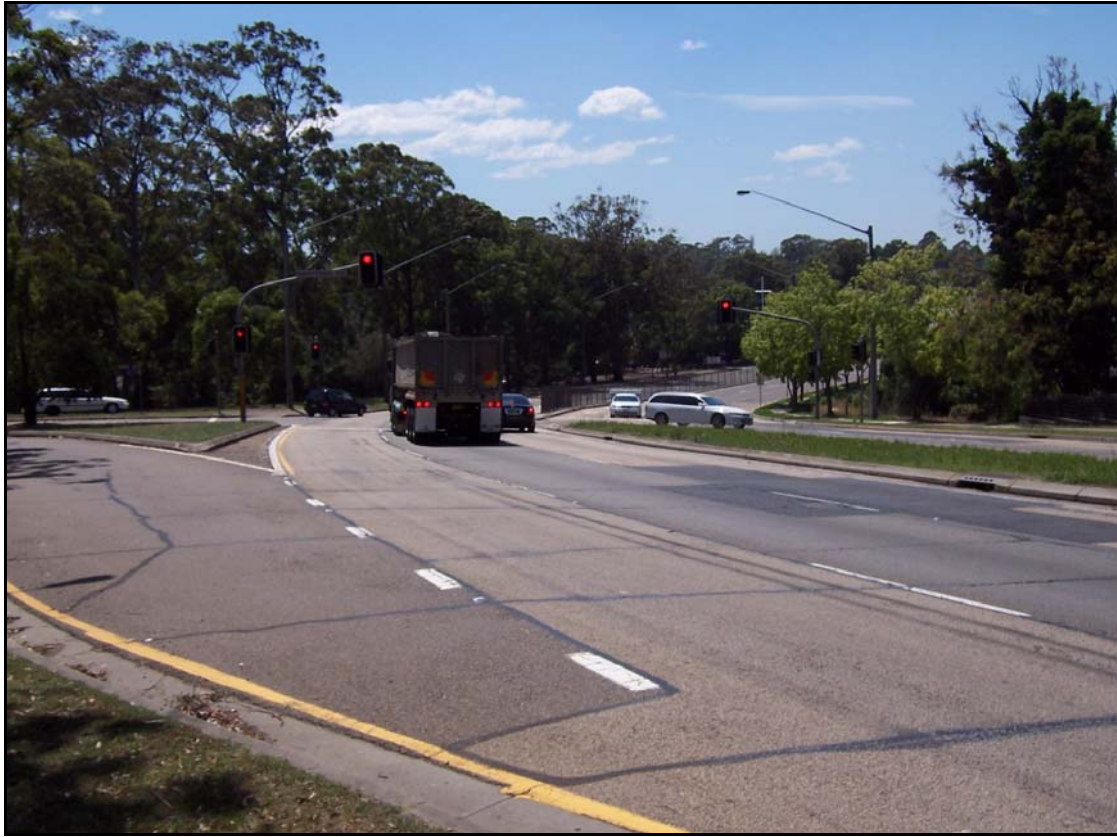
Figure 6.5: Site 5

In relation to the right-through crashes, the uphill start for the right turn (across three lanes) could mean that sight distance is likely to be insufficient for a full turn without collision risk to the side of the heavy vehicle.

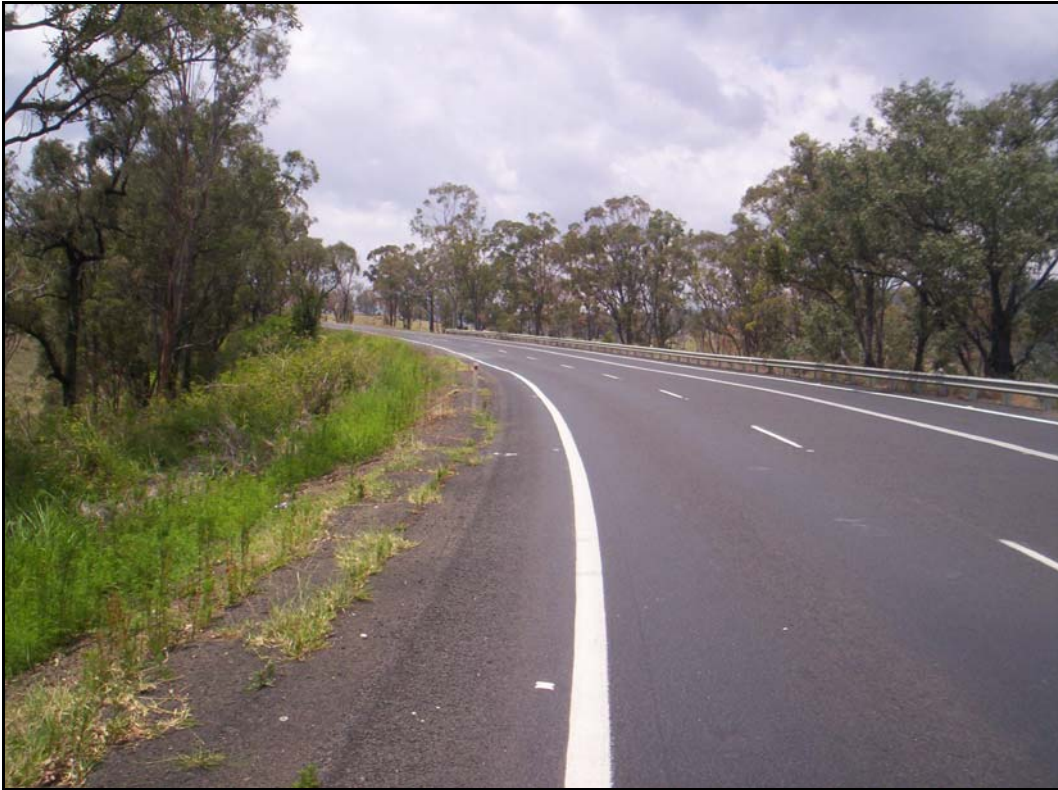
Figure 6.6: Site 6

6.1.6 Site 6 (Partially Sealed Shoulders, Steep Embankment, Inadequate Curve Delineation)

The site inspections revealed a lack of adequate night time curve delineation at some points, and only partially sealed shoulders, which may have been contributing factors. The presence of steep embankments at the roadside (Figure 6.6) may have contributed to the severity of the run-off road crashes that occurred.

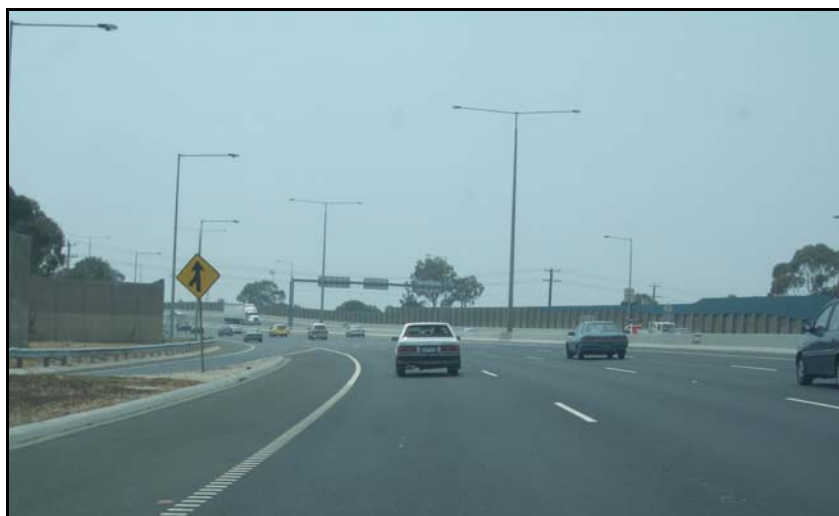
Figure 6.7: Site 7

There were four heavy vehicle crashes that occurred on this short segment (Figure 6.7). Two occurred during darkness, two occurred on a wet road surface and two occurred during the morning peak time. The crash type was different in each case (although all were 'same direction' crashes). Site inspections did not reveal any road-related potential crash causation factors while police crash narratives supported the notion that the crashes that occurred at this stretch were not the result of any particular road feature.

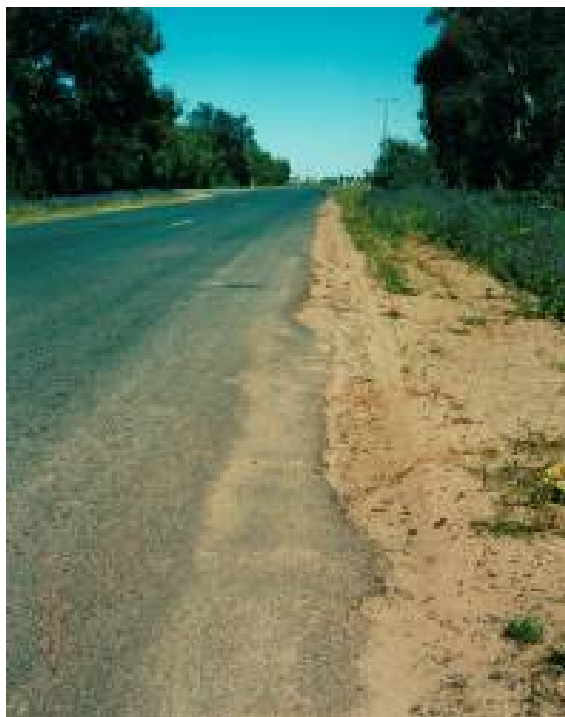
In Australia and New Zealand the majority of high speed rural roads consist of sealed-surface lanes, and unsealed shoulders, with crushed stones often used as the unsealed shoulder surface (McLean 2002). This practice can be extremely hazardous to heavy vehicles, as the width of such vehicles can result in their encroaching onto the road shoulder area. Additionally, where narrow seals are used in combination with high heavy vehicle volumes, the trailing vortices from heavy vehicles can erode the pavement binding material, thus turning shoulder edges into gravel. This can create edge 'drop-offs' which can promote ROR crashes. Poor road shoulder condition is depicted in Figure 7.1.

Figure 7.1: Poor road shoulder condition

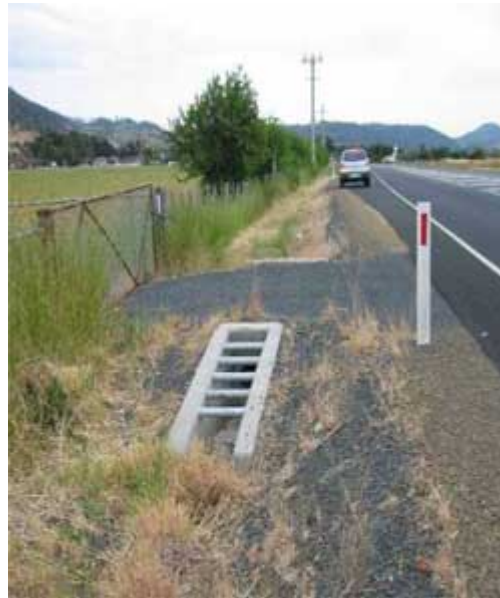
The alteration of the hazard in most cases also provides an acceptable solution, and can be achieved in the form of various innovative designs. For example, light poles have been designed which absorb energy on impact, thus lessening injury to vehicle occupants and culvert end walls can be made 'driveable' (Figure 7.2).

Figure 7.2: Driveable culvert

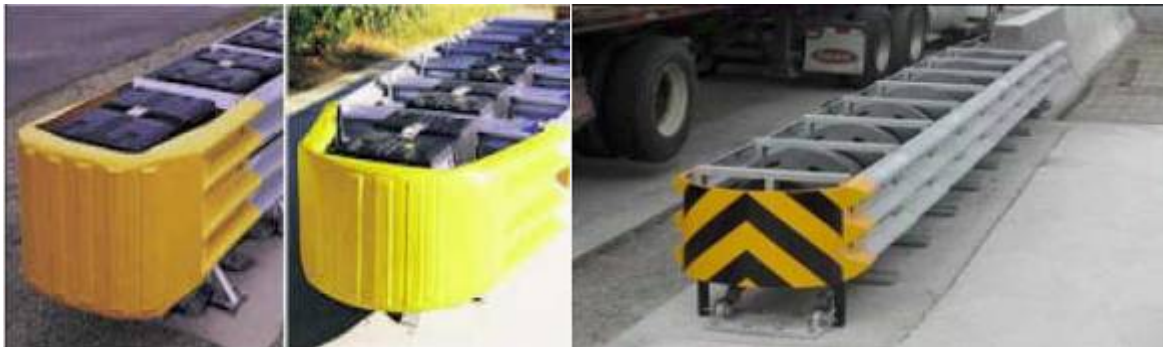
The Australian experience with impact attenuators is not particularly detailed with regards to the evaluation of such measures but impact attenuators have been included on many Australian freeways and highways. Common types of permanent crash cushions complying with ASNZ 3845:1999 are shown in Figure 7.3.

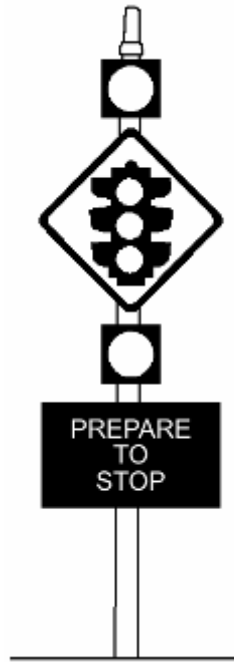
Figure 7.8: Advance warning signals

Advance warning signals can be used in advance of intersections to provide additional advance notice to drivers. The Guide to Traffic Engineering Practice – Part 7 suggests that advance active warning signals such as those depicted in Figure 7.8 (and as opposed to passive warning signs) can be used on arterial roads with a high proportion of heavy or long combination vehicles, a high risk of infringement of the intersection signals and a high risk of rear-end or cross crashes due to the inability to stop in time for the red display. They can also be used when the traffic signals are obscured from the view of approaching traffic.

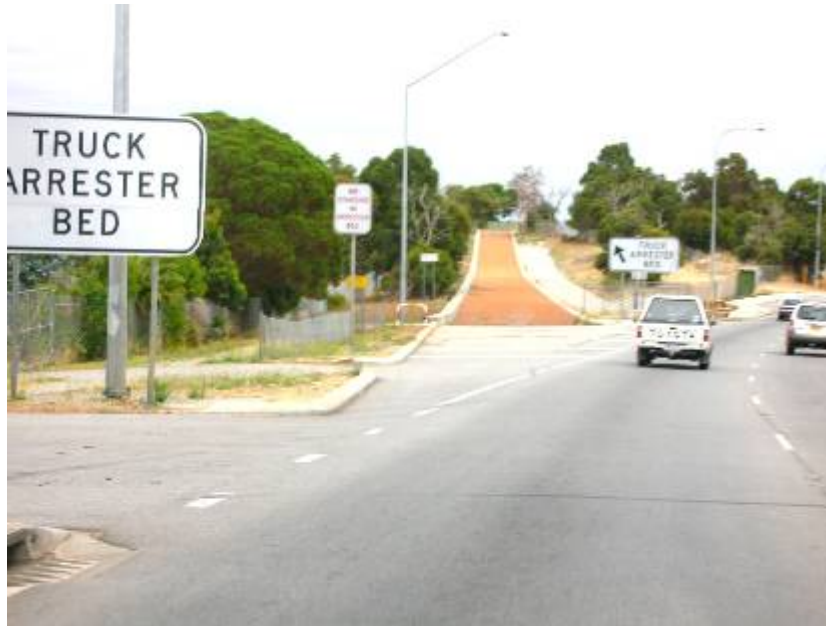
Figure 7.9: Truck arrester bed (Greenmount Hill, Perth)

Due to the small proportion of crashes which are attributed to heavy vehicle brake failure, the availability of reliable data which describes the effectiveness of such facilities is extremely limited. Western Australia's first arrester bed, situated on the Great Eastern Highway near Perth, as shown in Figure 7.9, was constructed in 1993 following a multiple fatal crash and is reported to have been used by heavy vehicles several times since.

Local research has previously been conducted which indicates the potential for truck escape ramps and arrester beds to successfully capture errant vehicles (Nielsen 1996). Through such studies general recommendations into the determination of requirements for arrester beds, geometric factors describing their construction, and general advice as to the type of aggregate material which should be used have been developed (Austroads 2003a). To date however there are no specific nationally recognised guidelines which outline the design and installation of these facilities. Various Australian state road authorities currently have their own guidelines for the implementation of such facilities, and advocate their use be factored into the initial design of roads with steep grades, rather than as a reactive countermeasure based on the occurrence of crashes.

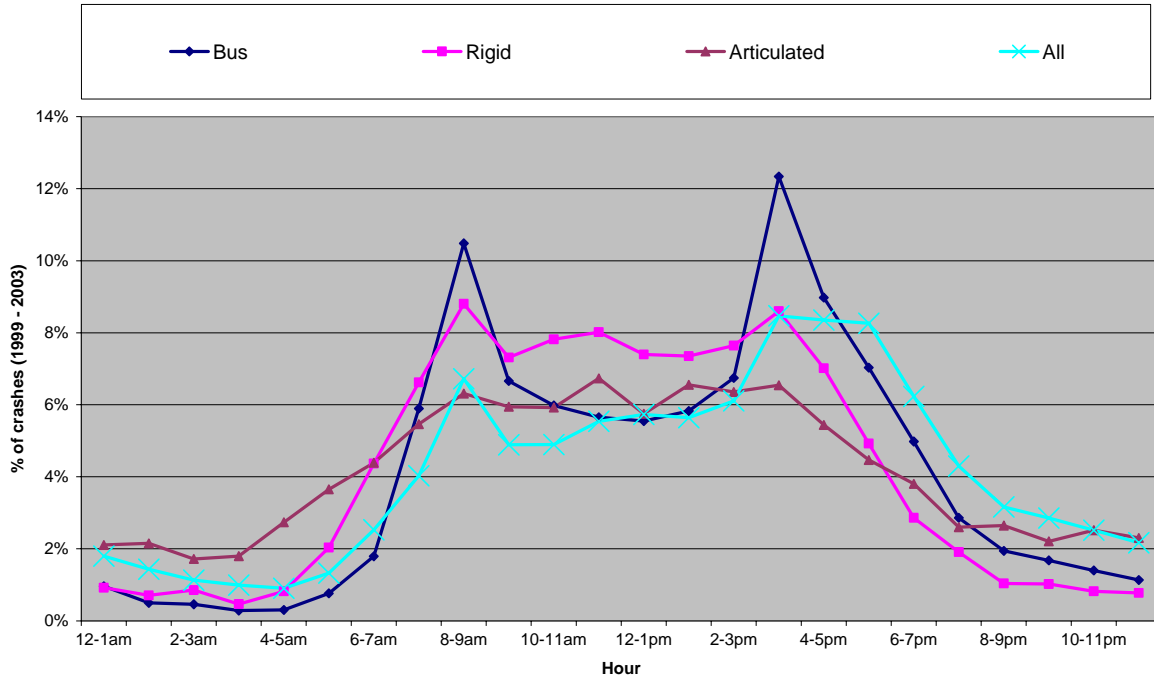
Figure C 3 and Figure C 4 show evidence of peaks in rigid truck and bus crashes during peak commute times (8am to 9am and 4pm to 6pm). The morning and afternoon peaks for bus crashes are more pronounced than those for rigid trucks and for all crashes, which probably reflects the fact that a major role for buses (perhaps even more so than privately owned light vehicles) is commuter transport.

Figure C 3: Crashes by time of day (Australia)
